Recreational Boat Collision Accident Research

Volume 1

Miles A. Beam III, P.E.
Senior Project Engineer
Marine Department

Underwriters Laboratories Inc.

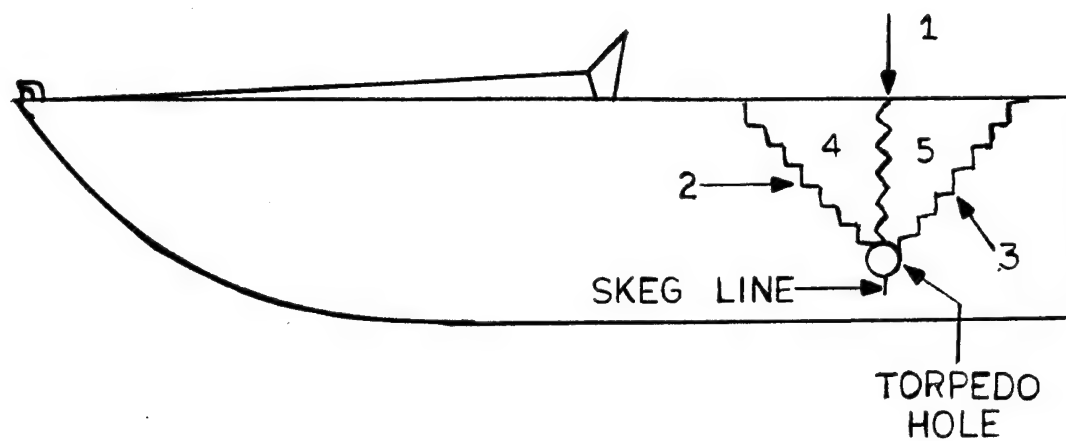
Figure 6-1

Typical Damage to Hull Side After Collision

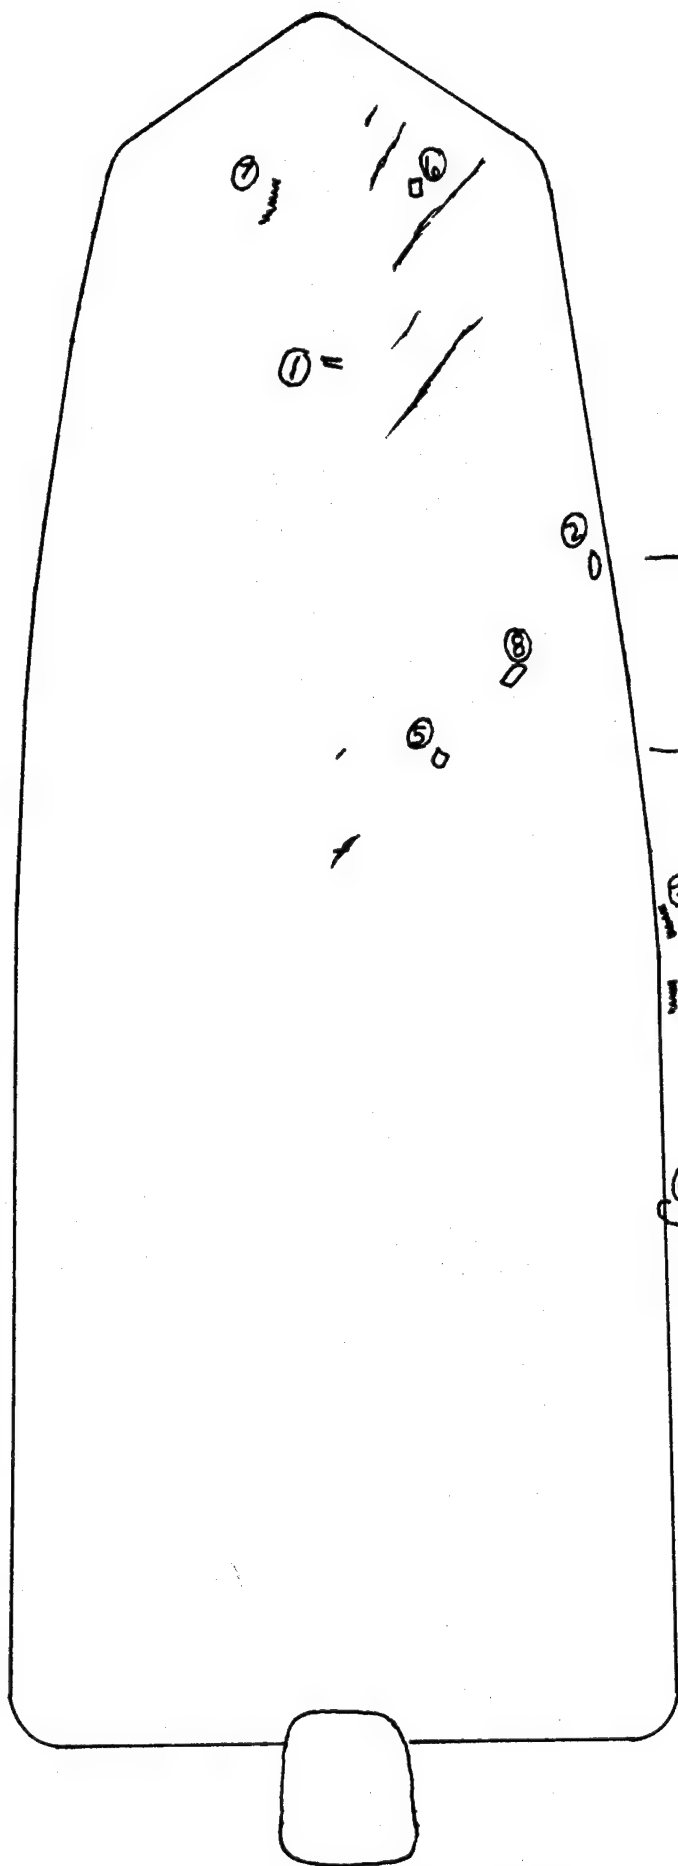
Bullet Boat Damage Diagram
Figure 13-3

- ① chip on bow
- ② cleat w/chips from other boat
- ③ Rub Rail marks on Side
- ④ Small Chip above Rub Rail
- ⑤ Large Chunk off Spray Rail
- ⑥ Chunk from outside Spray Rail
- ⑦ Bottom damage
- ⑧ Chunk on last spray rail

Accident No 1
Bullet Boat

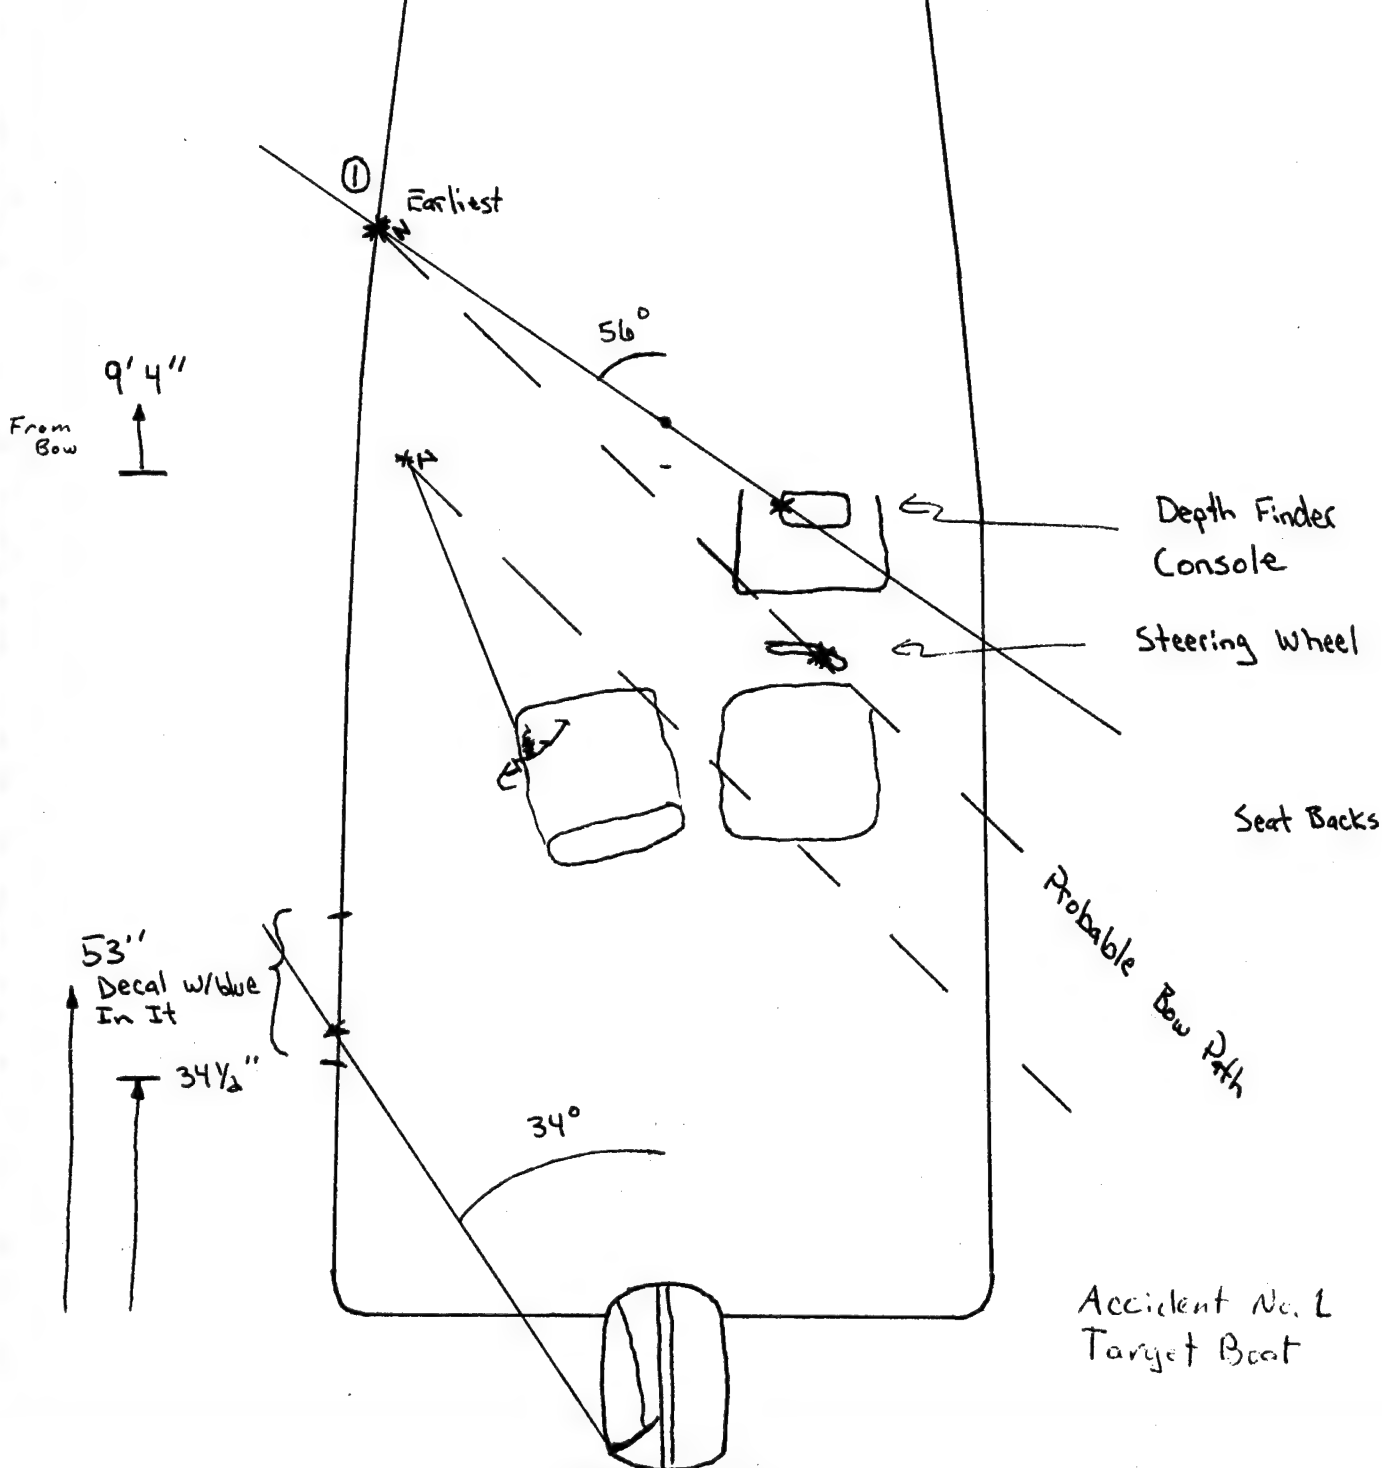
Figure 13-7

Accident No:1, Striation Analysis for $\theta_2 = 101$ degrees.

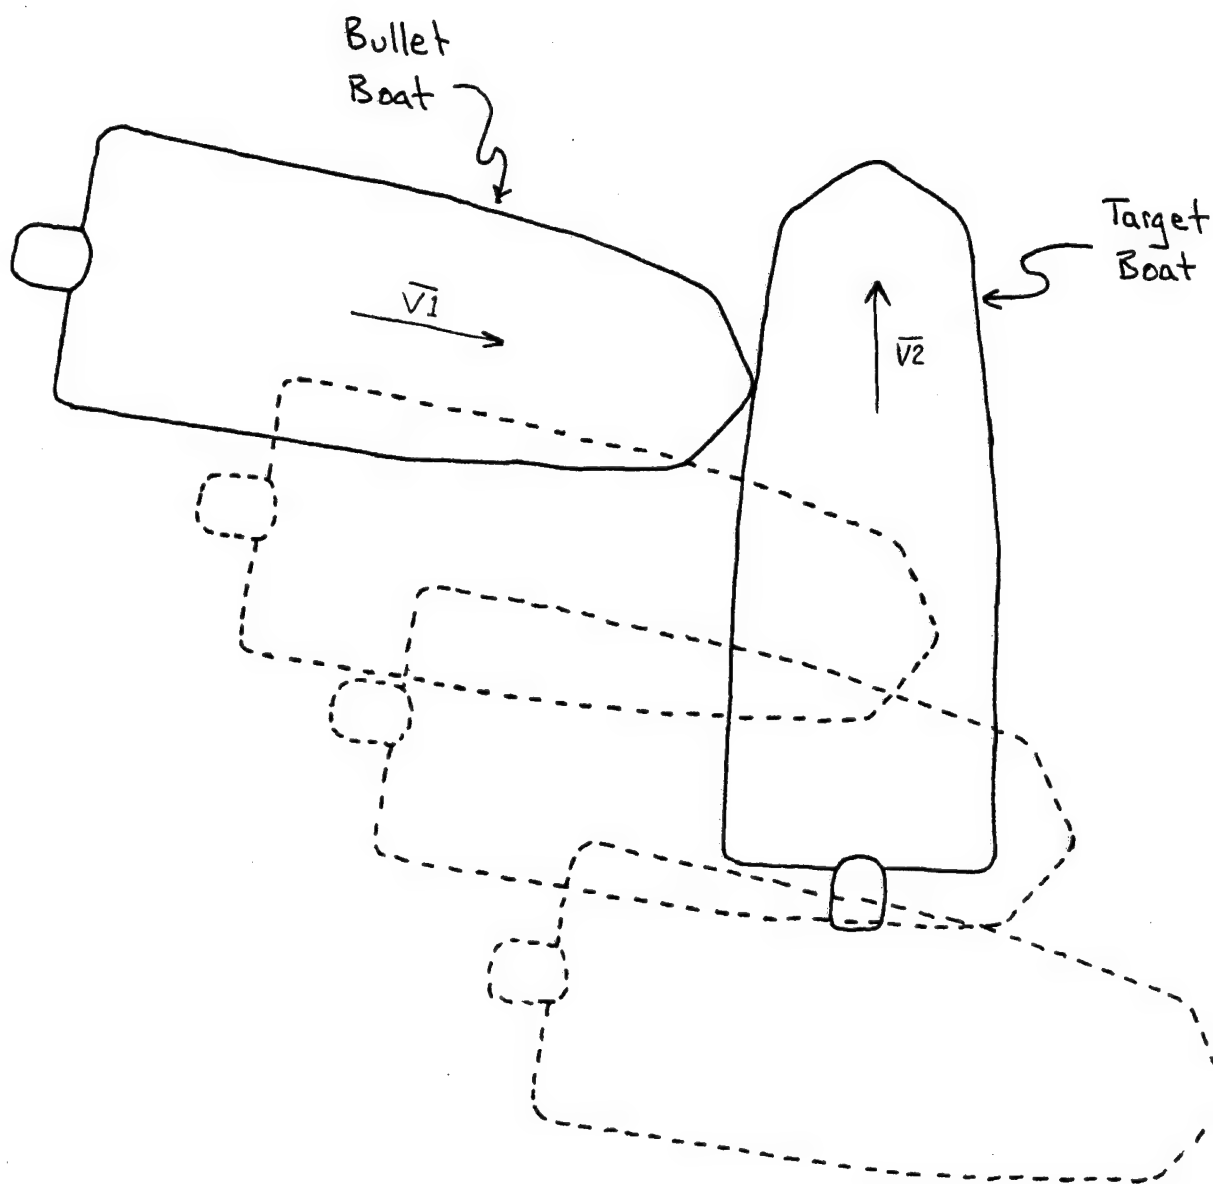
Figure 13-11

Approximate Path of the Bullet Boat Across the Target Boat.

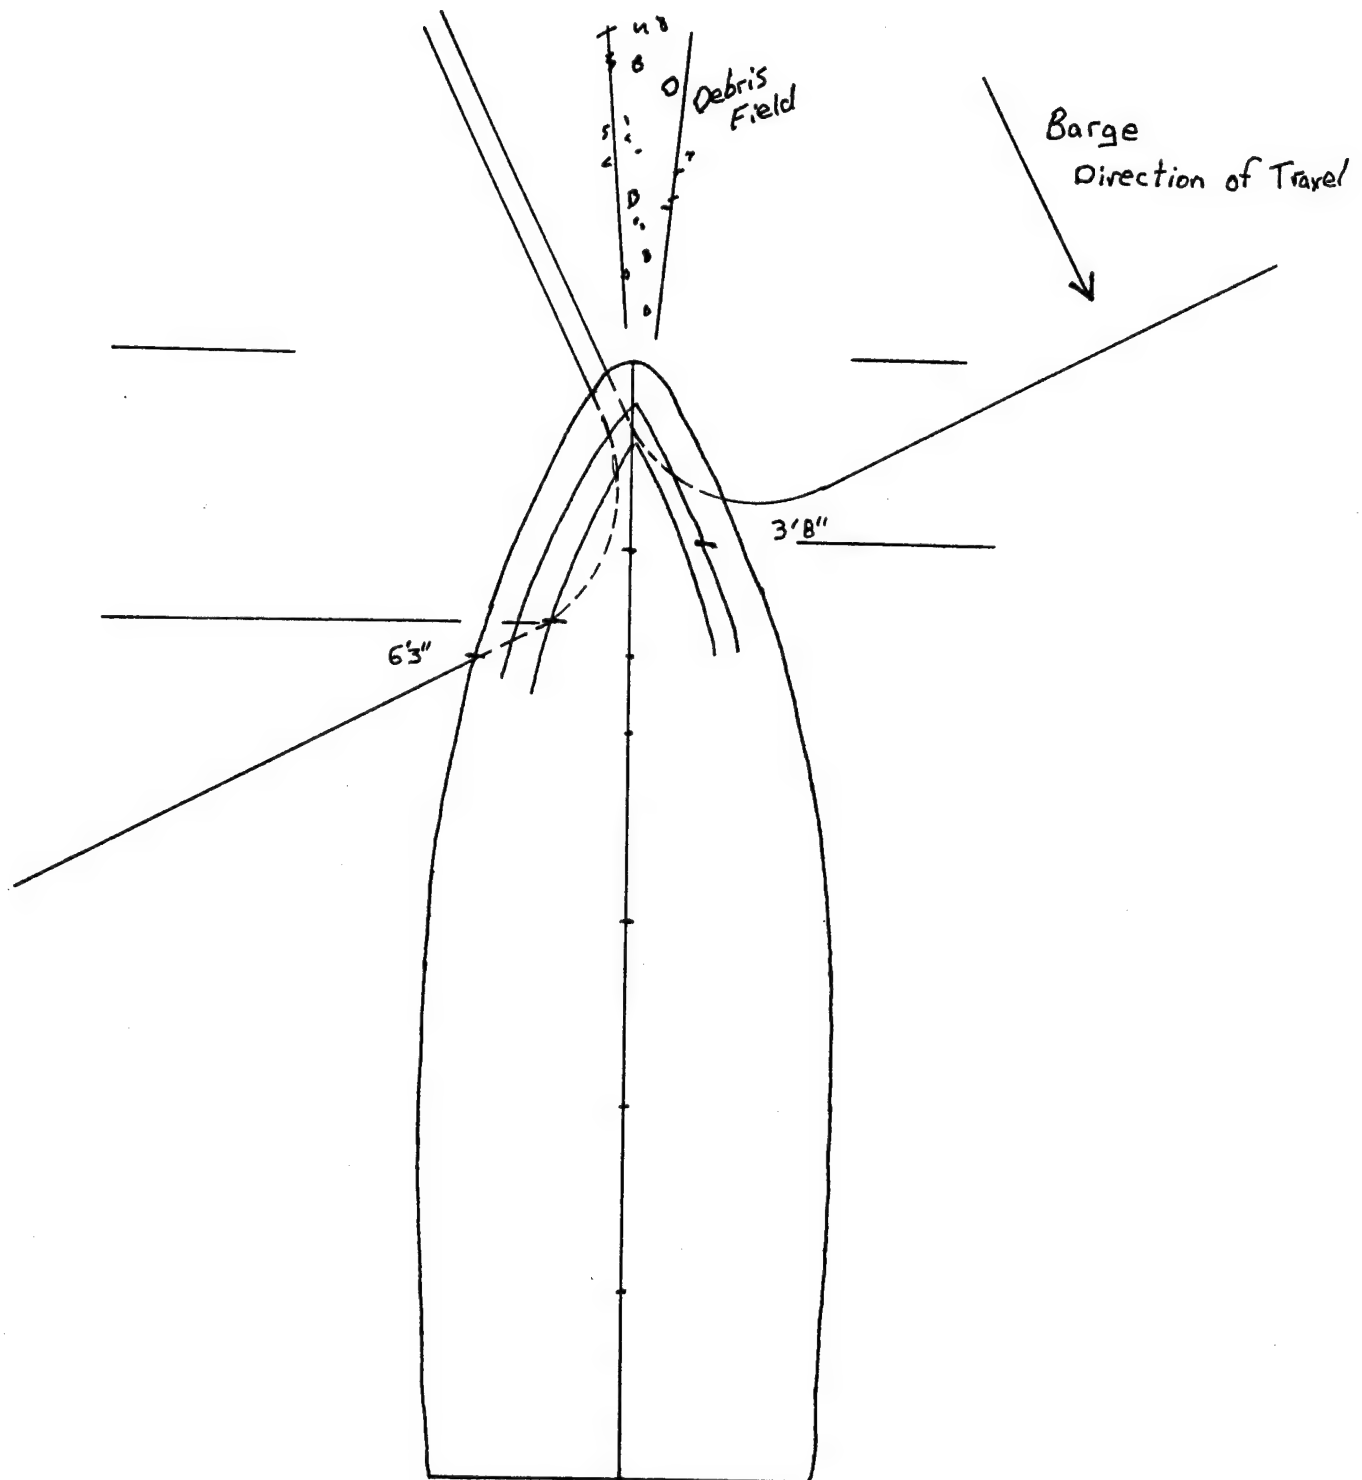
Figure 13-35

This Diagram Shows How Much of the Barge May Have Penetrated the Hull.

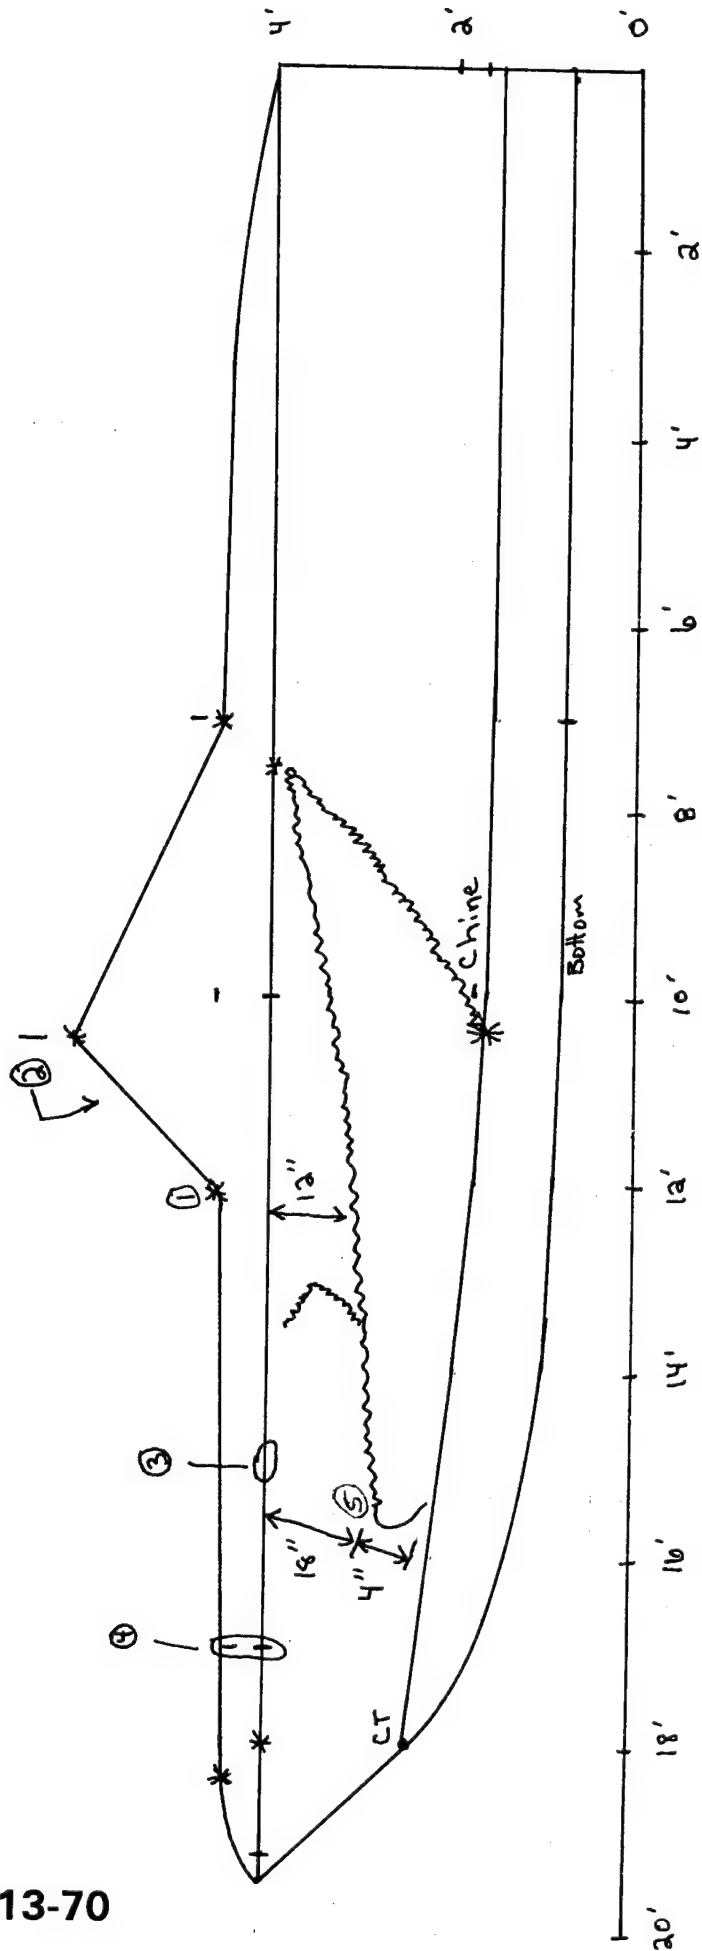
Figure 13-70

- ① WS Front
- ② WS Angle = 48°
- ③ 1" red smear on rub rail
- ④ 16' 11" = # on tape
- ⑤ Possible nav light impact point

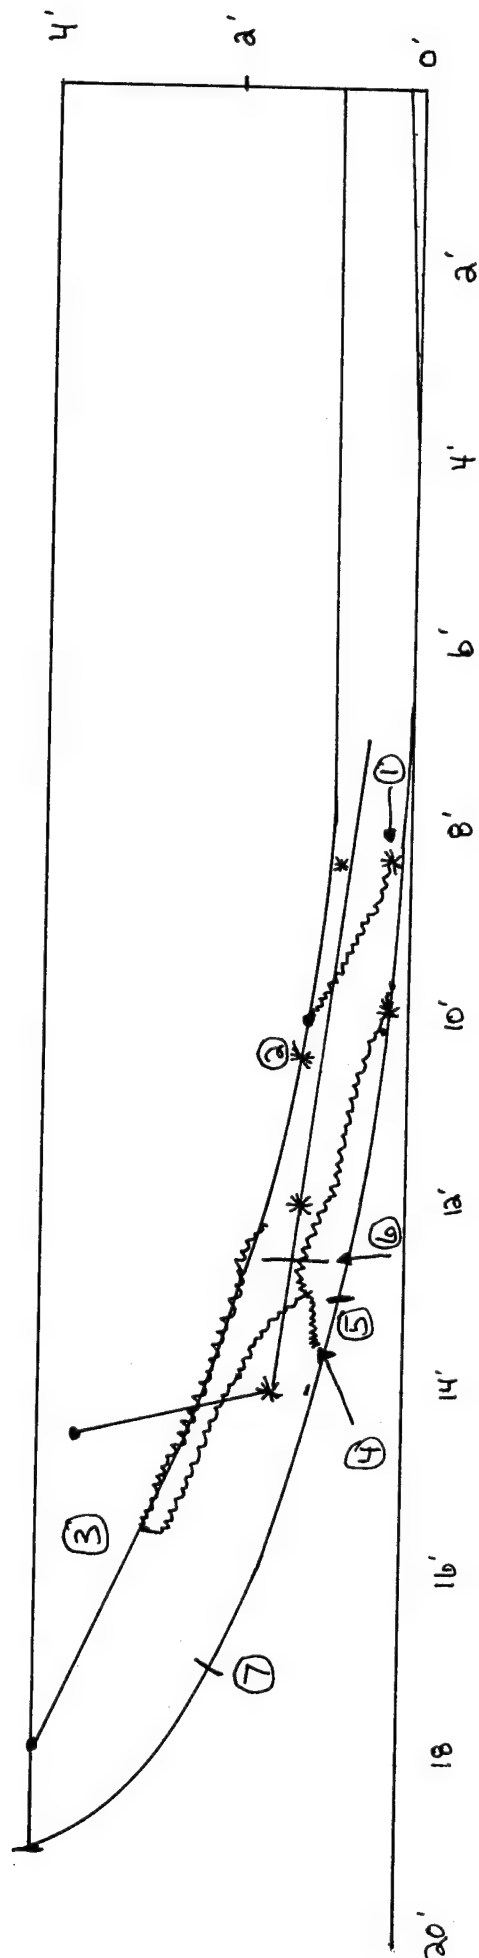
Figure 13-71

- ① end of "hole"
- ② hole at chime - aft
- ③ beginning of hole at chime - fwd
- ④ crack
- ⑤ main crack line
- ⑥ vertical cut
- ⑦ red paint transfer on rub rail
